Clamshell Door Failure

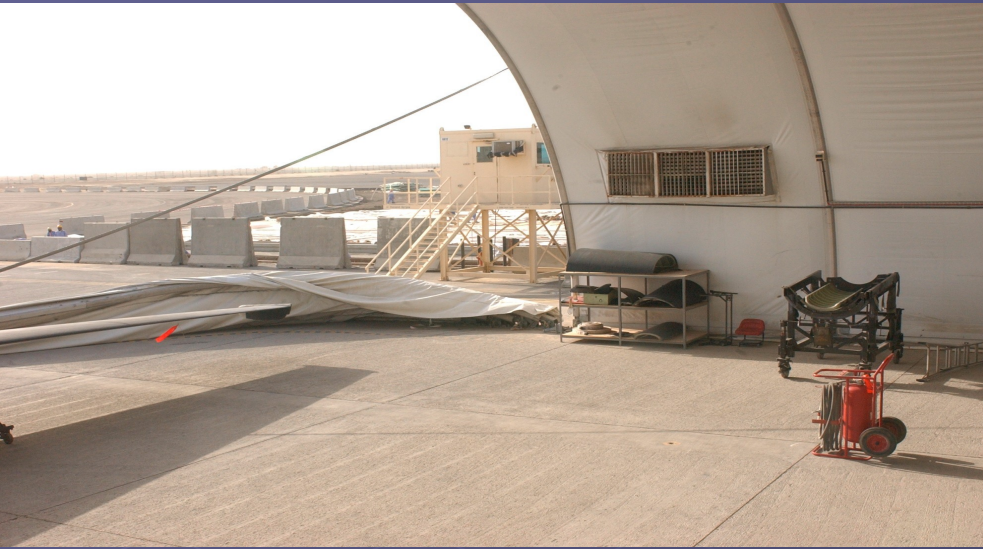
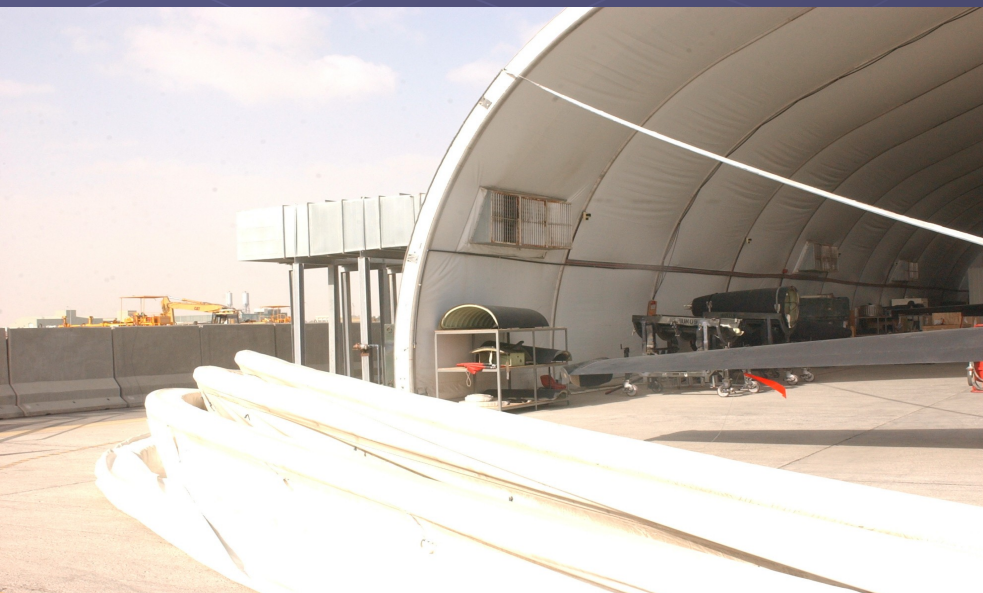
On 26 Jan 05 the fabric seam of a Clamshell style aircraft shelter door failed catastrophically, causing it to fall to the ground and narrowly miss personnel and the tail of an aircraft parked in the structure.

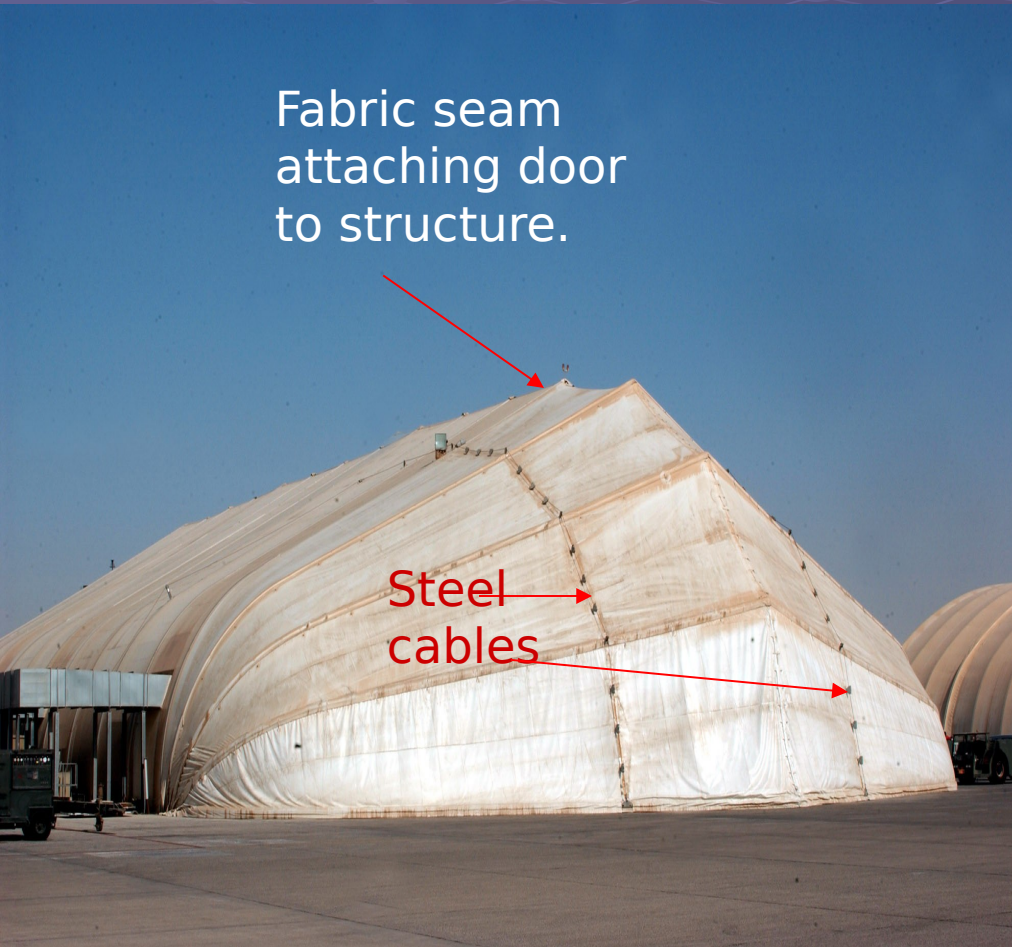
The Clamshell door was in the closed position as shown in the photo when the failure occurred. The failure started in the indicated area and the door fell in an “accordion” style to the ground. In the shown configuration the door structure is reliant on the fabric seam which attaches to the front structural arch of the facility. The door is raised and lowered by two steel cables running along the front outside which are attached to a winch and pulley system. As the door is opened the tension is transferred from the fabric seam to the steel cables.

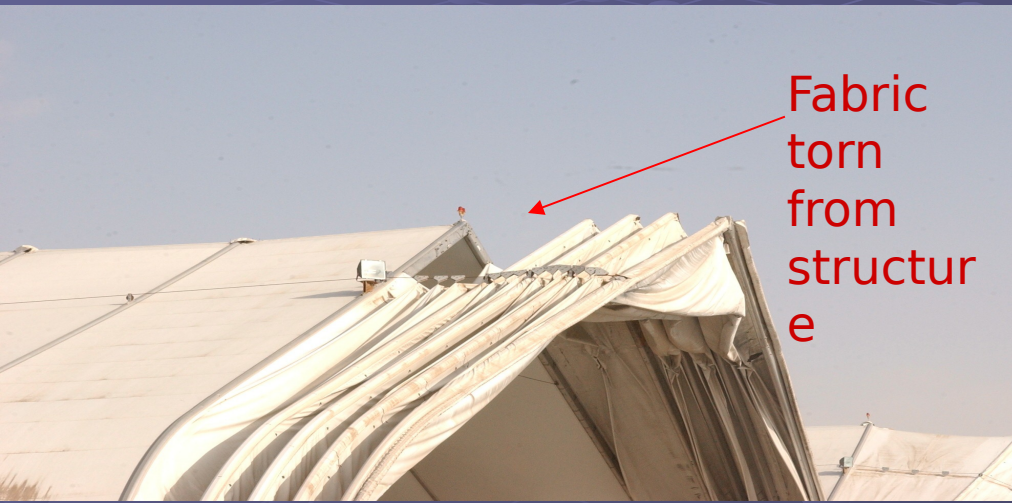
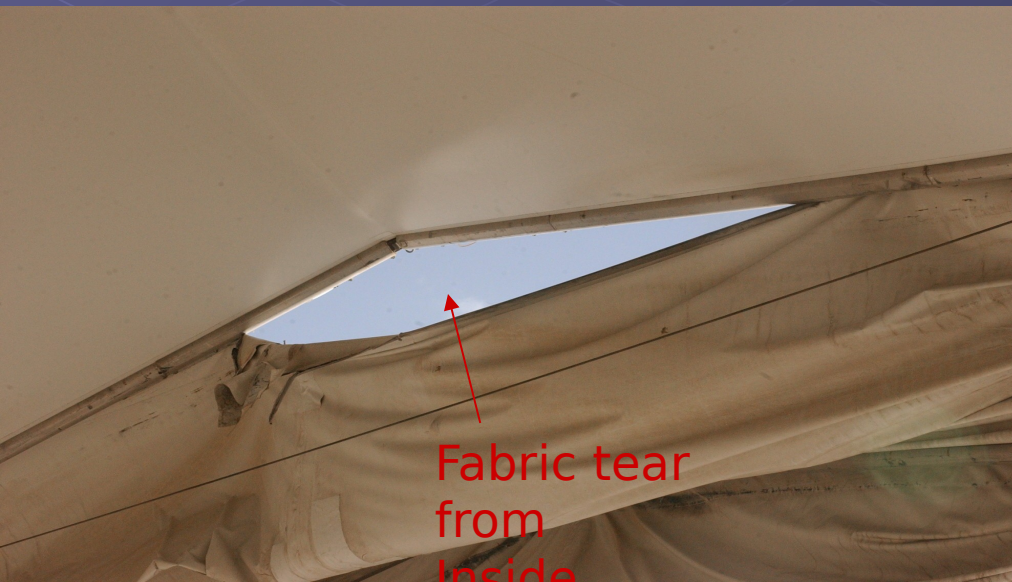
The fabric seam at the top of the mishap Clamshell door had been ripped similar to the door in the picture for approximately a month prior to the failure. Prior to the mishap it was not realized that the fabric seam was an integral part of the door support design. The material to fix the door was on the base and the Statement of Work for the contract was being finalized at the time of the mishap. The structure is produced by

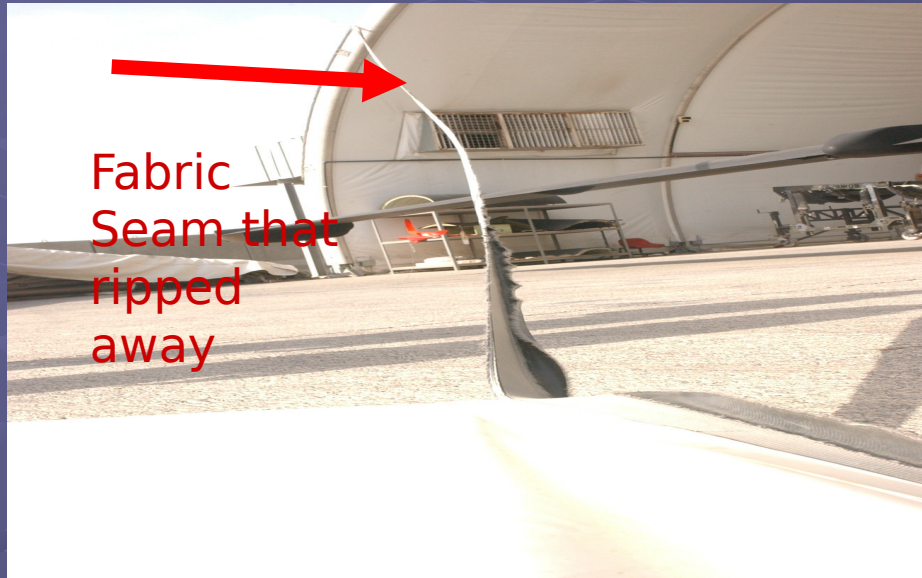
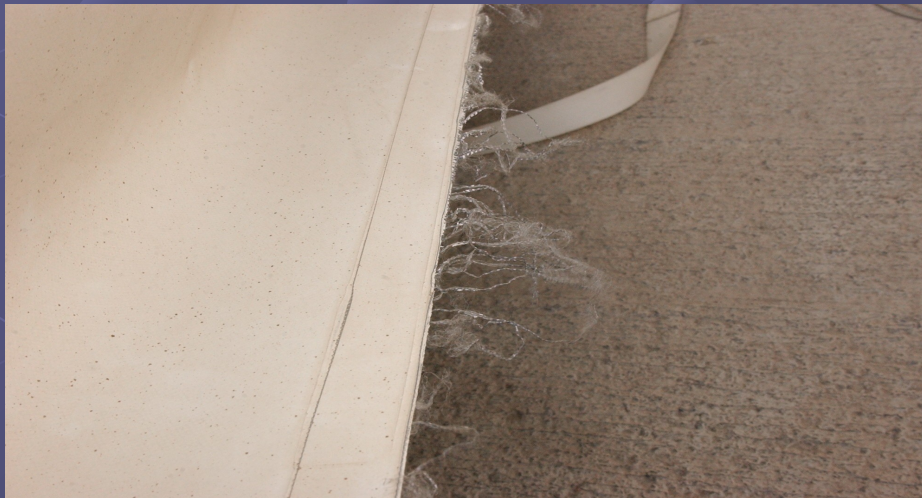
Witnesses to the mishap stated that the door had been opened earlier in the day to move equipment into the hangar. After the door was closed the tear had had grown from the top and traveled almost all the way down the left side. The door failed shortly after this
